Preliminary Study on Fatigue Strengths of Fretted Ti-48Al-2Cr-2Nb

Kazuhisa Miyoshi, Bradley A. Lerch, and Susan L. Draper
Glenn Research Center, Cleveland, Ohio

The Aerospace Propulsion and Power Program at
NASA Glenn Research Center sponsored this work.

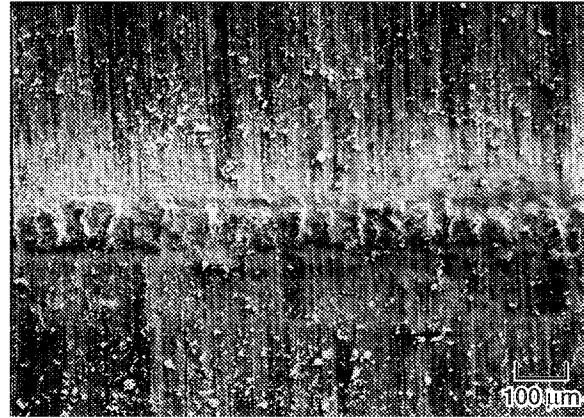
Figure 9.—Wear scar with wear debris particles produced on Ti-48Al-2Cr-2Nb fatigue specimen in contact with superalloy contact pad. Table 2(b.2) presents the fretting conditions.

Figure 9 shows a typical example of a wear scar with wear debris from fretting produced on the Ti-48Al-2Cr-2Nb fatigue specimen in contact with the superalloy contact pad. Because of the specimen geometry, a large amount of wear debris is deposited just outside the line contact area. Pieces of the Ti-48Al-2Cr-2Nb and its oxides are generally torn out or sheared off during fretting.

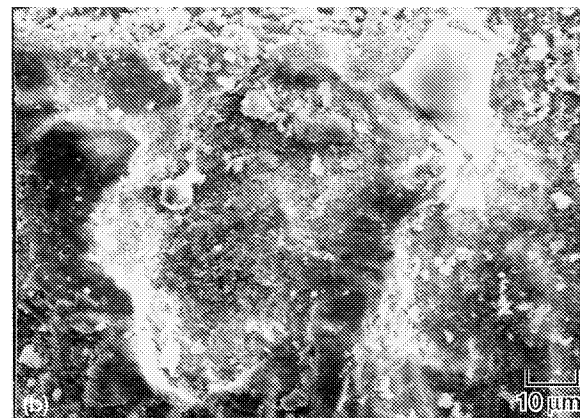
Figure 11.—Surface damages produced on both (a) Ti-48Al-2Cr-2Nb fatigue specimen and (b) superalloy contact pad. Table 2(b.2) presents the fretting conditions.

On the other hand, figures 11(a) and (b) show examples of the Ti-48Al-2Cr-2Nb and superalloy surfaces that are torn out or sheared off during fretting. There are fractured pits, flakelike wear debris, and oxide wear particles in the contact areas of both Ti-48Al-2Cr-2Nb and superalloy surfaces.
